# Montgomery County Fire and Rescue Service Post Incident Analysis

## Townhouse Fire

13311 Woodruff Court  
Germantown, MD  
December 8, 2009

Incident #09-0128490  
0744 Hours

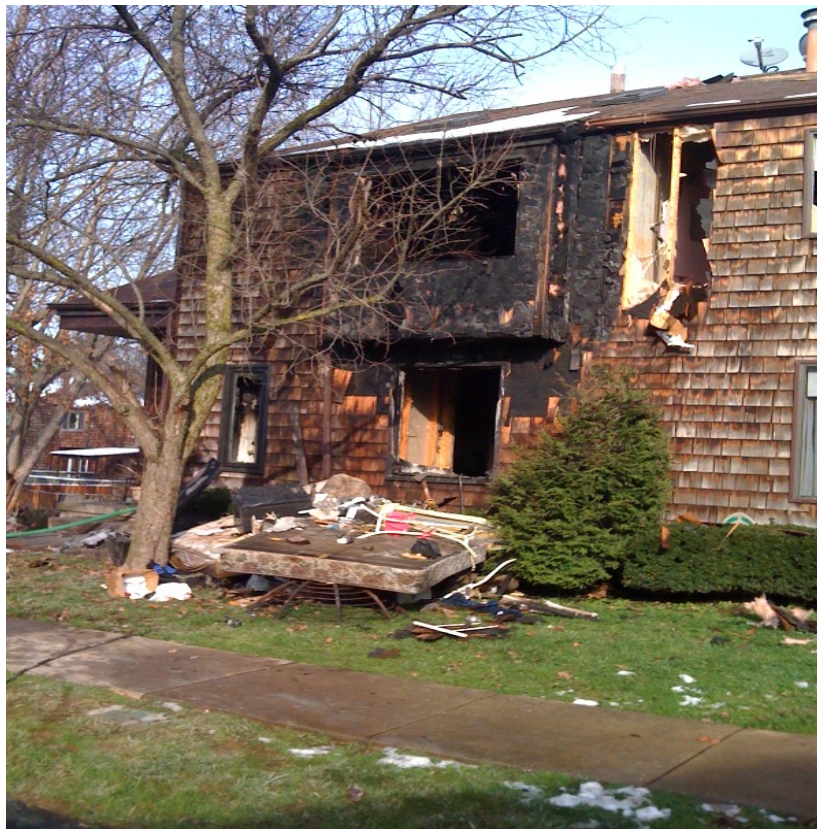
- This structure is a three story in the rear, two story in the front wood frame townhouse, constructed in the early 1980s.
- There was an exterior entrance on side Charlie to the basement area.
- Walls on the Bravo and Delta were constructed of wood framing with double thickness drywall that extended through the entire roofline providing firewall protection between the fire building and the Delta exposure.

- Inside end unit of first row of townhouses on a dead-end court.
- There was adequate access to side Alpha of the row, with side Charlie being a common area grass lawn that was fenced, preventing fire apparatus access.
- No hydrants on Woodruff Court itself, however, the hydrant that Engine 729 split laid to was less than 100 feet from the intersection of Woodruff Court and Waldorf Drive. There was also a hydrant at the corner of Waldorf Drive and Father Hurley Boulevard, less than 200 feet from the structure.
